Report 500-87.25

FEB 9 1987
PACIFIC GAS AND ELECTRIC COMPANY
DEPARTMENT OF ENGINEERING RESEARCH
3400 Crow Canyon Road
San Ramon, California 94583

LABORATORY TEST REPORT

SUBJECT: EVALUATION OF J-HOOKS AND EYES FROM 115KV OLEUM G-LINE

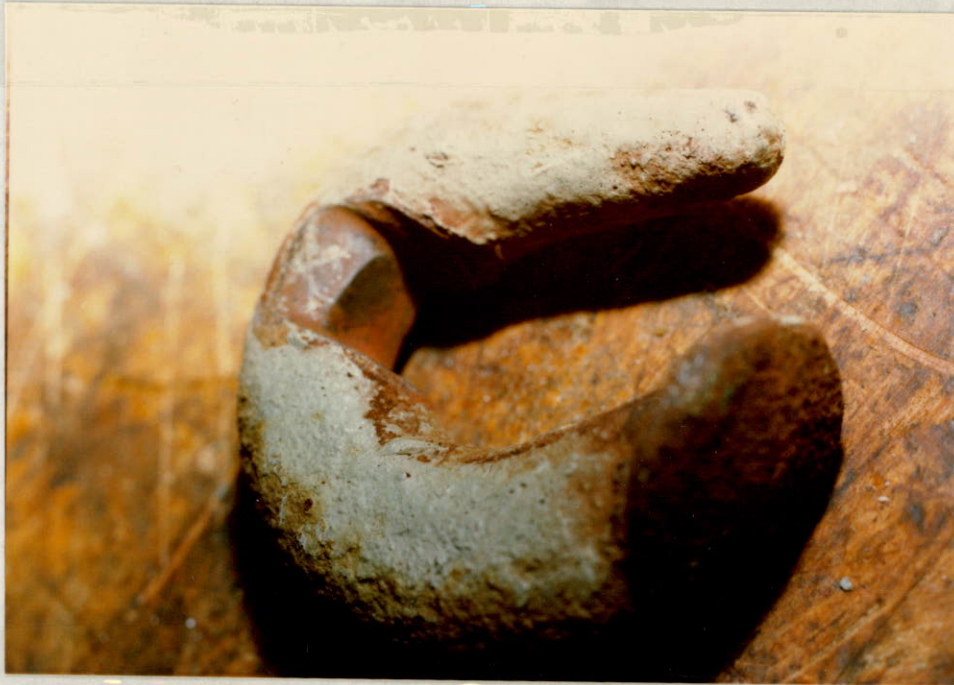
Both of the J-Hooks and their attaching plates had grooves worn in them and there was a concern that they may not be able to hold the weight of insulator strings that are suspended from them, (See Figures 1 and 2).

Figure 1. As shown in the Figure above a wear pattern was formed in the bowl-saddle of the J-Hook. This was possibly caused by the insulator string swinging in the wind over a period of time.

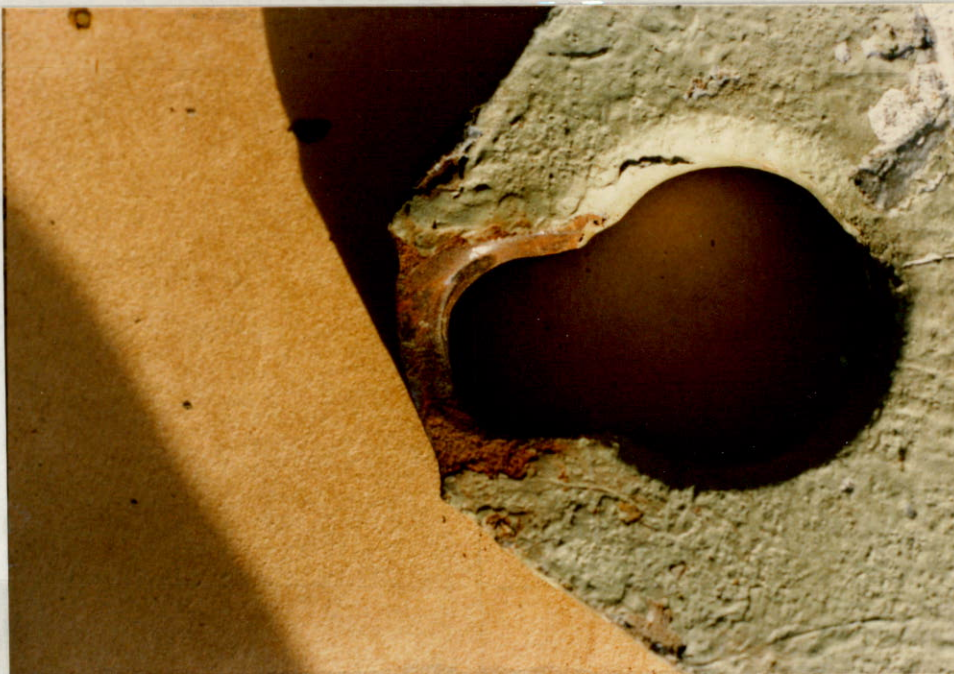
Figure 2. This Figure shows the key-hole wear in the plate eye caused by the J-Hook while in service.

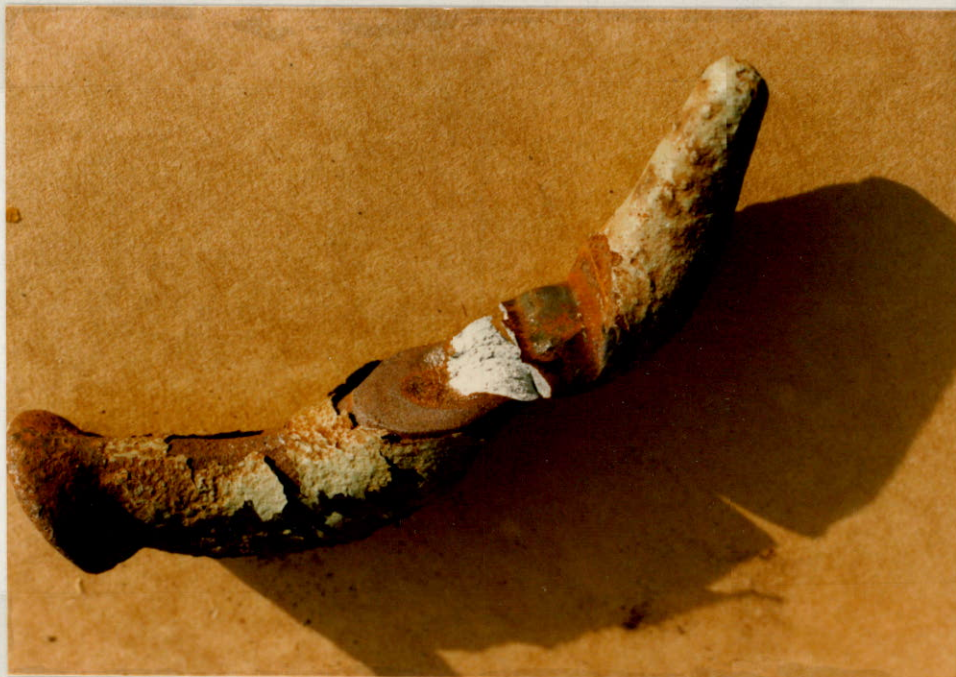
Both hooks failed at 11,500 lbs., (See Figures 4 and 5). Since the plates did not fail during this test an additional test was done on one of the plates. A shackle was attached to the eye of the plate and tension was applied. The eye failed at 19,600 lbs., (See Figure 6).

Figure 4. This hook shows the point of failure to be in the worn section of the bowl-saddle.

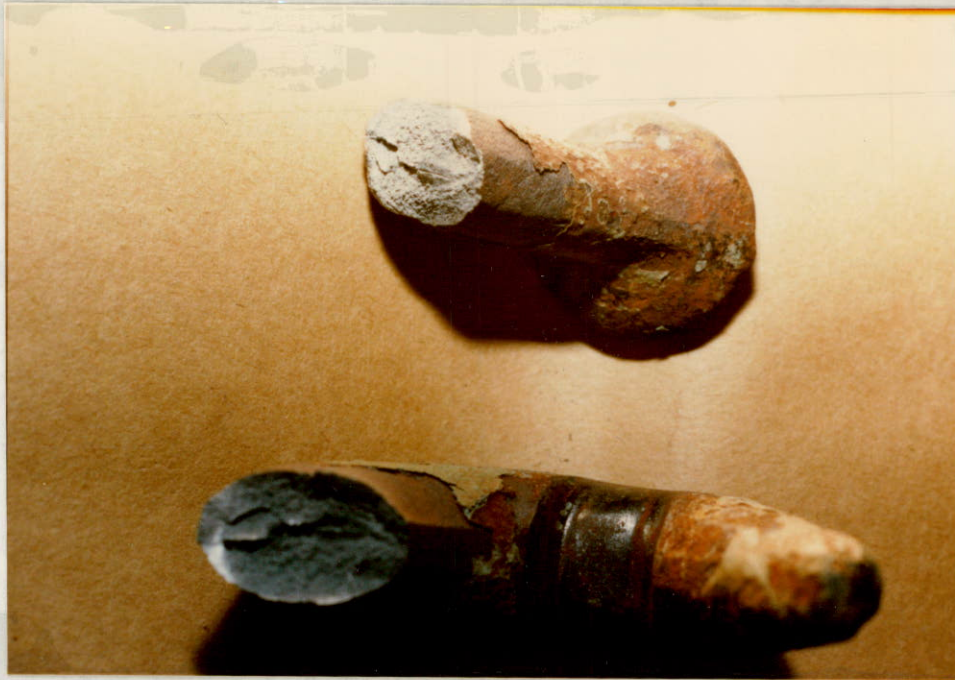
Figure 5. This hook failed at the heel even though it had approximately the same wear pattern in the bowl-saddle as the hook in Figure 4.

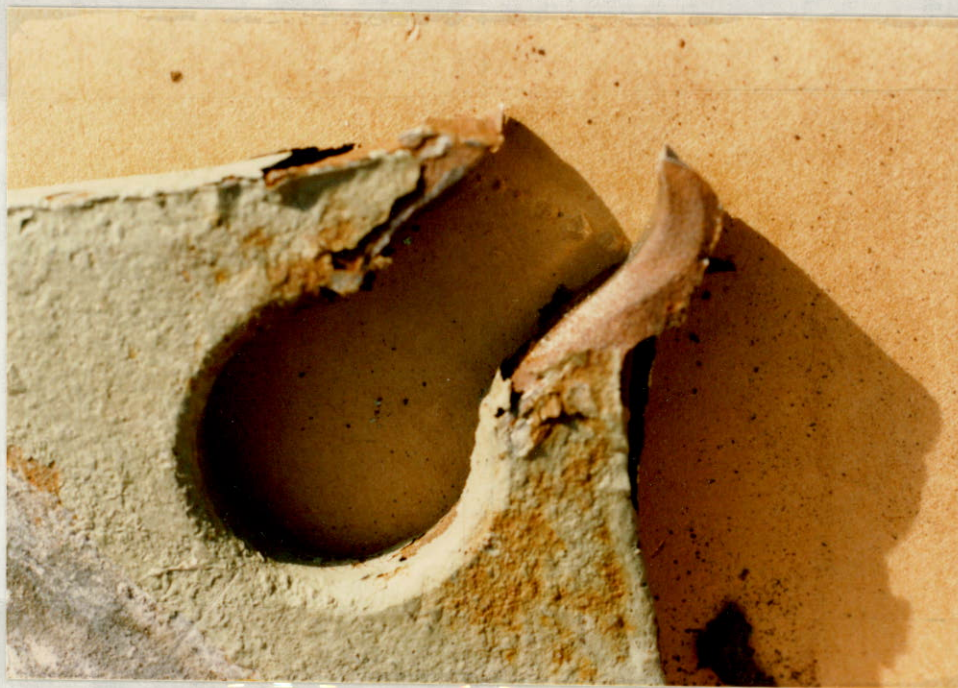
Figure 6. This Figure shows the failure of the eye in the plate when a shackle was pulled through it.

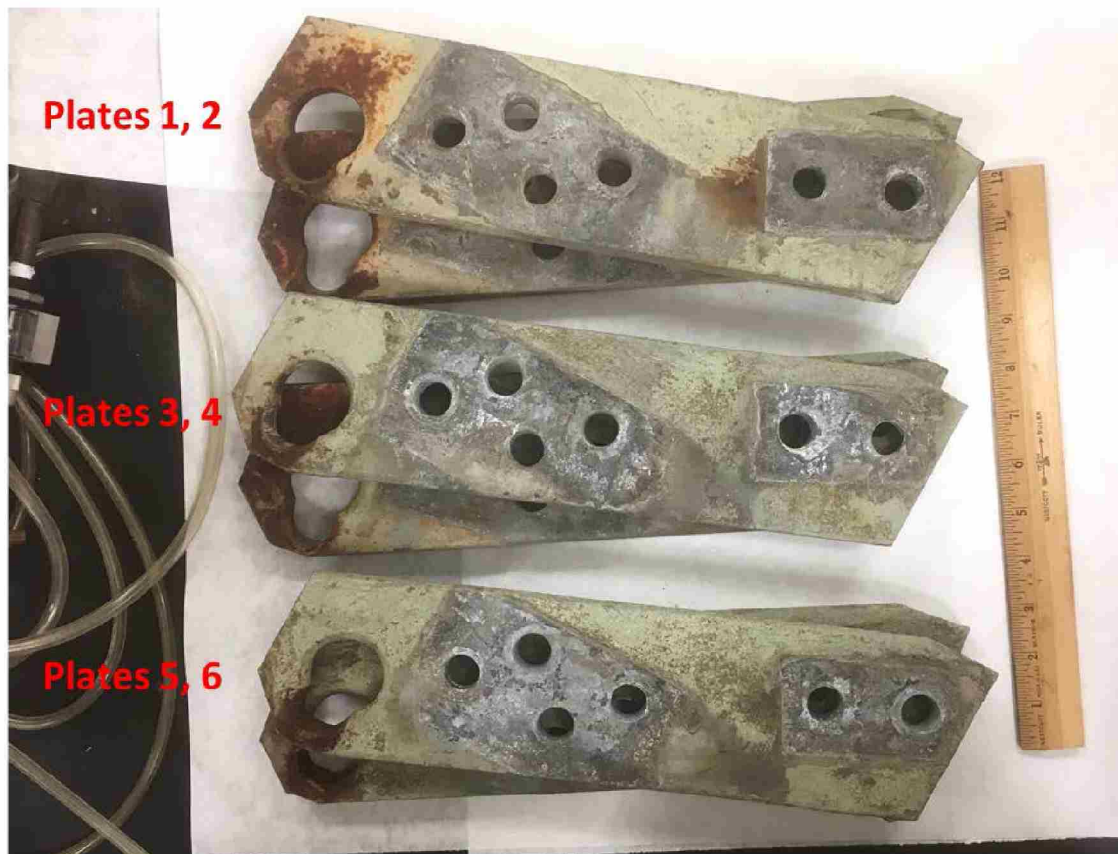
Figure 1: As-received photograph of six suspension plates submitted to ATS for evaluation.

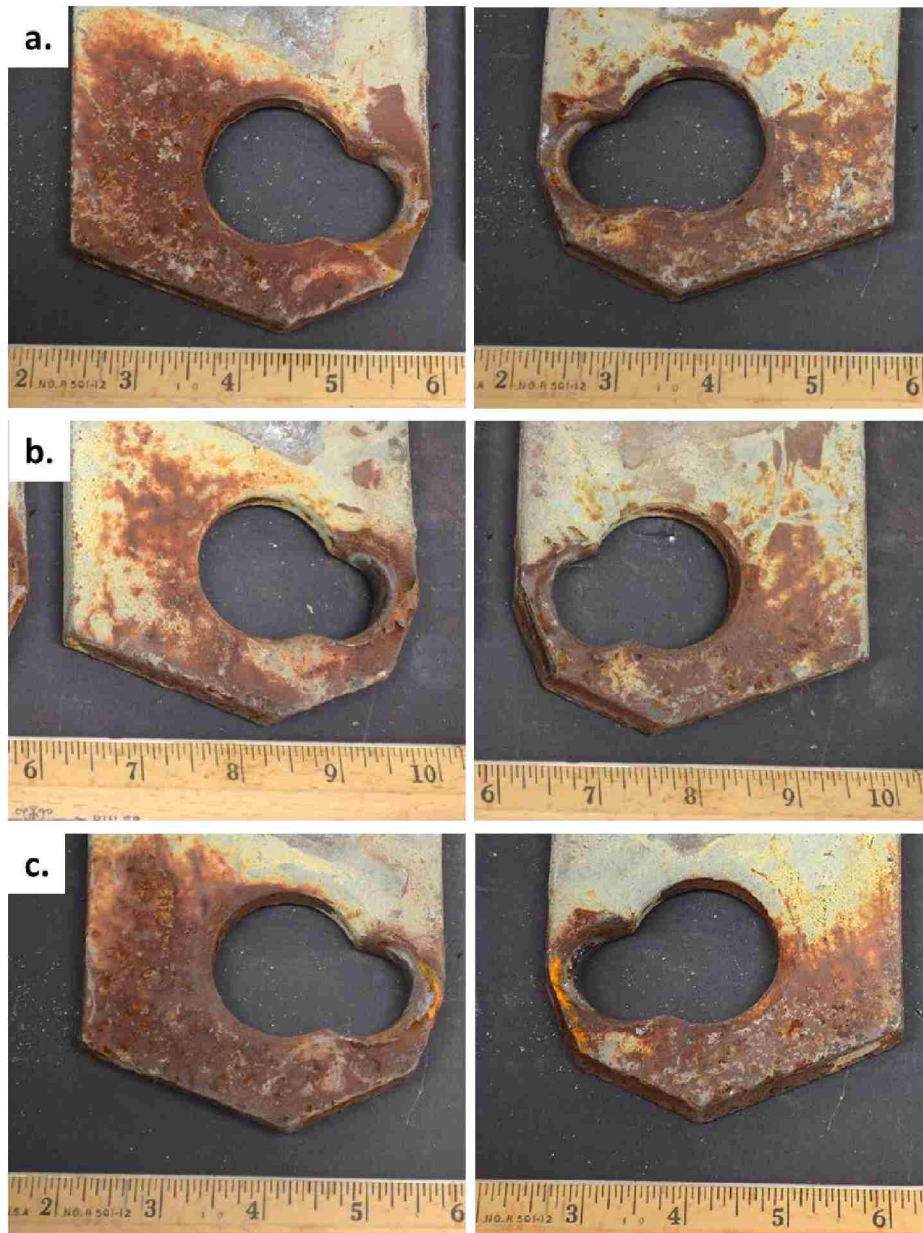
Figure 3: Front- and back-side views of the insulator attachment point for: a) Plate 1, b) Plate 2, and c) Plate 3. These three plates show more corrosion than Plates 4-6 (Fig. 4) and are likely to have come from the downwind side of the structure (the Bahia-Moraga line).

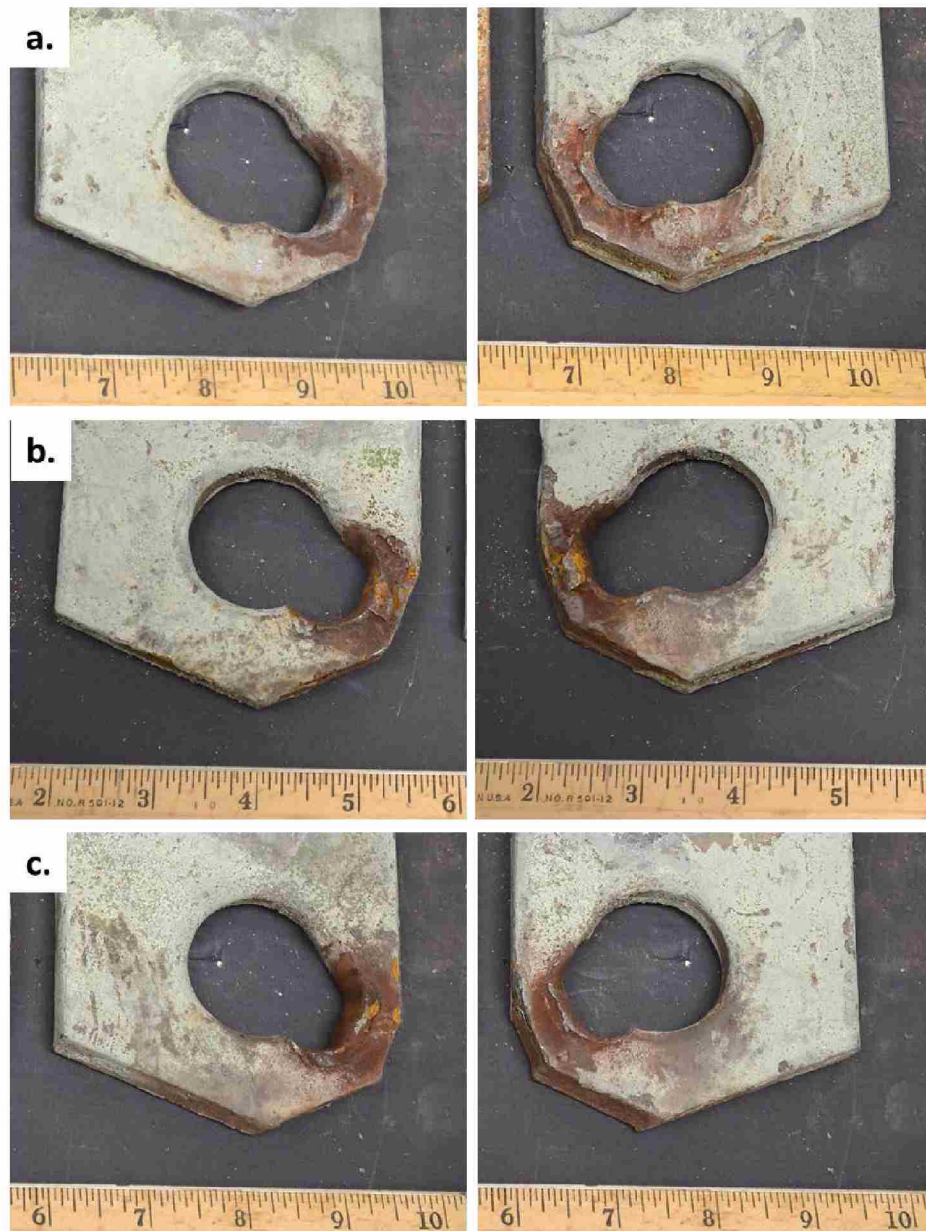
Figure 4: Front- and back-side views of the insulator attachment point for: a) Plate 4, b) Plate 5, and c) Plate 6. These three plates show less corrosion than Plates 1-3 (Fig. 3) and are likely to have come from the upwind side of the structure (the Parkway-Moraga line).

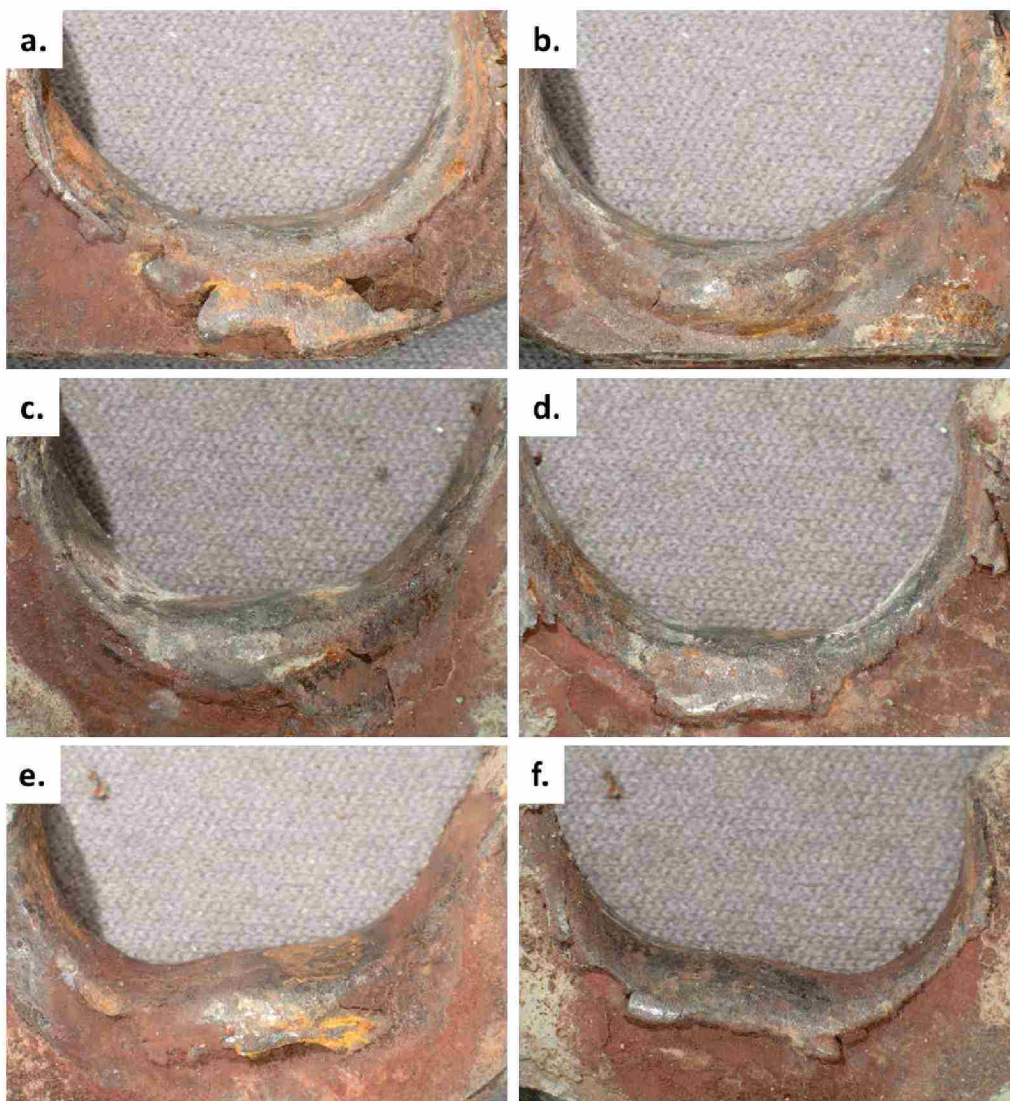
Figure 4: Close-up views of the front- and back-side of the insulator attachment point. (a, b) Plate 2, (c, d) Plate 4, (e,f) Plate 6. These views show substantial wear and plastic deformation.

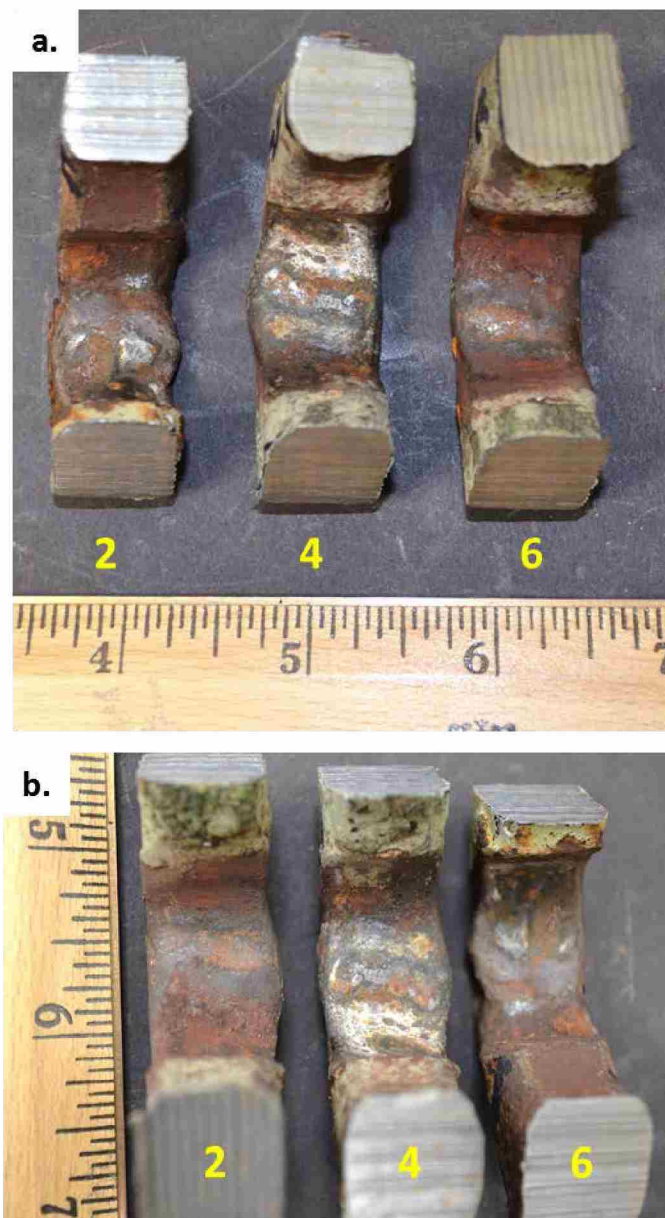
Figure 6: Views of the wear surface from Plates 2, 4 and 6, showing plastic deformation and uneven wear.

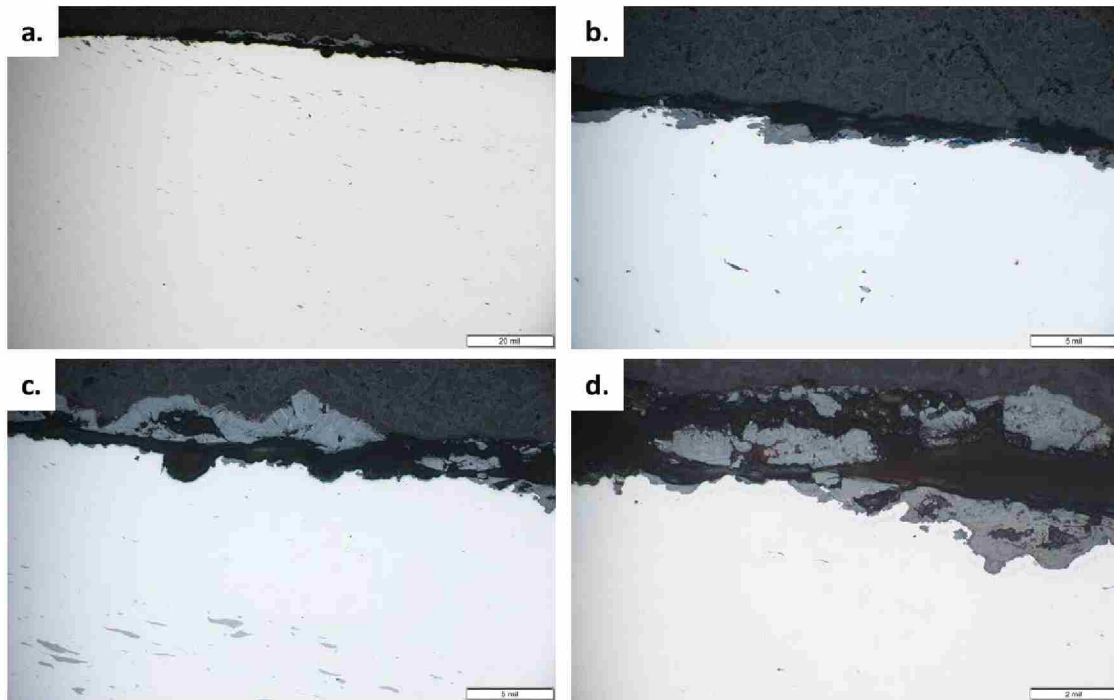
Figure 9: Polished cross-sections parallel to the wear surface from Plate 6. (a) 50x, (b, c) 200x, and (d) 500x. The images show corrosion and pitting, and plastic shearing at the surface. No cracking was observed anywhere in the cross-section.

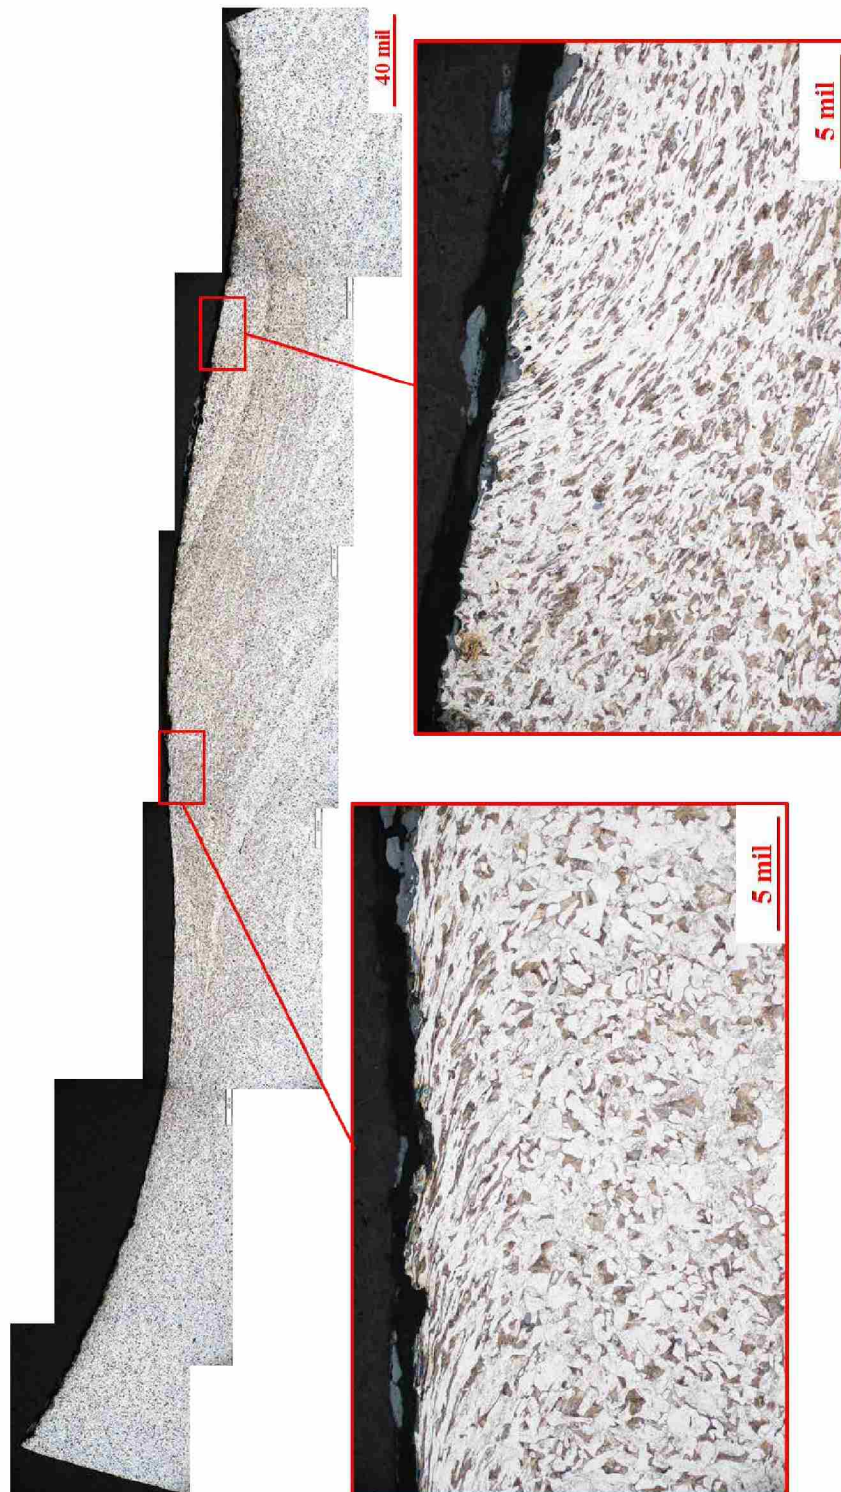
Figure 10: Etched cross-section of the wear surface shown in Fig. 9. The images show uneven wearing and shear deformation of the microstructure below the surface.

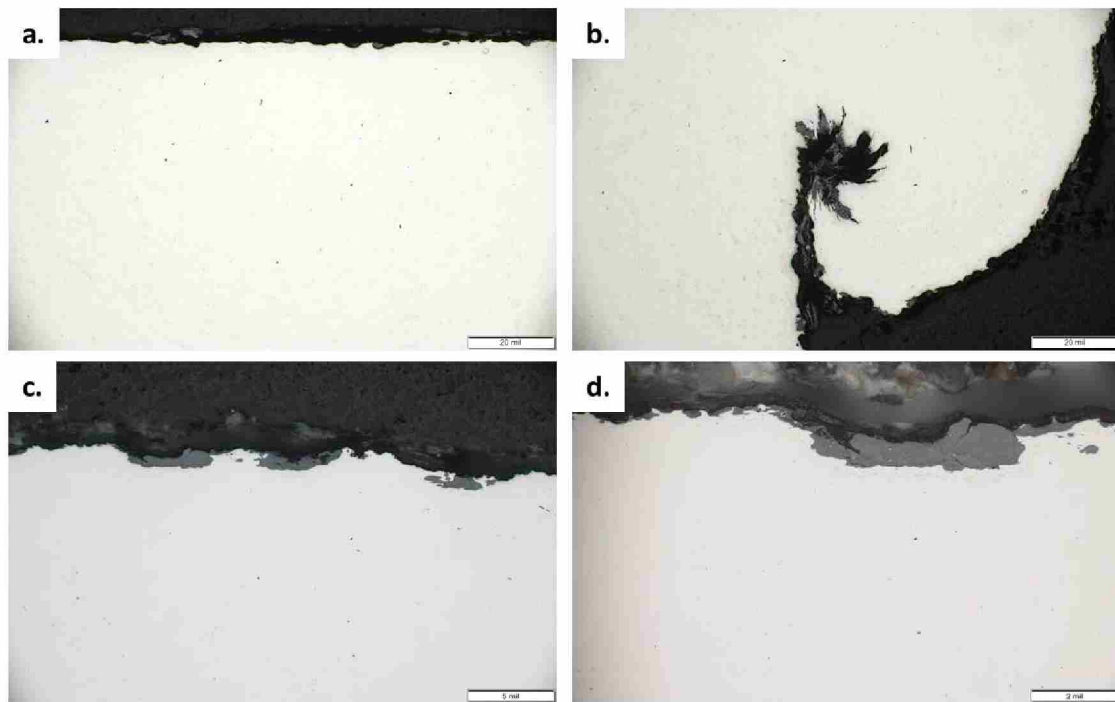
Figure 11: Polished cross-sections perpendicular to the wear surface from Plate 2. (a) 50x, (b, c) 200x, and (d) 500x. The images show corrosion and pitting, and plastic shearing at the surface. No cracking was observed anywhere in the cross-section.

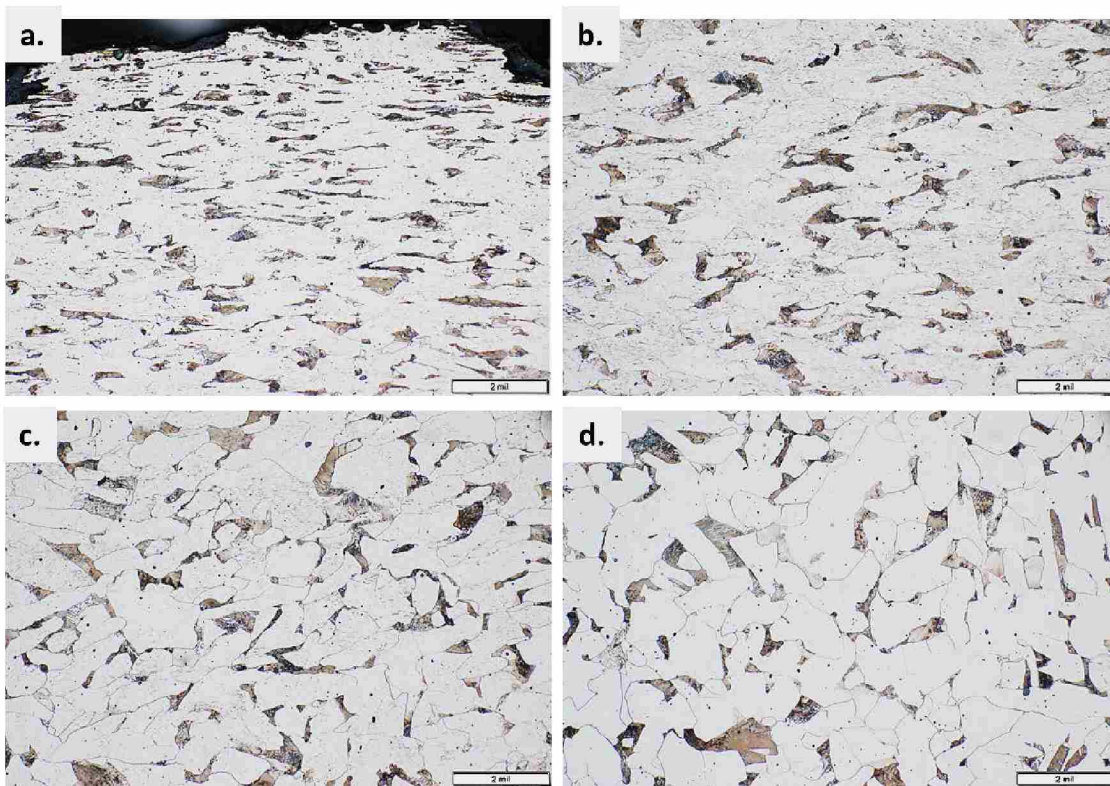
Figure 12: Polished cross-sections perpendicular to the wear surface from Plate 2, all at 500x magnification. (a) Near-surface, (b) approximately 0.010" below the surface, (c) approximately 0.045" below the surface, and (d) approximately 0.065" below the surface. The images show severe plastic shearing at the surface, and decreasing disturbance to the microstructure with increasing depth.

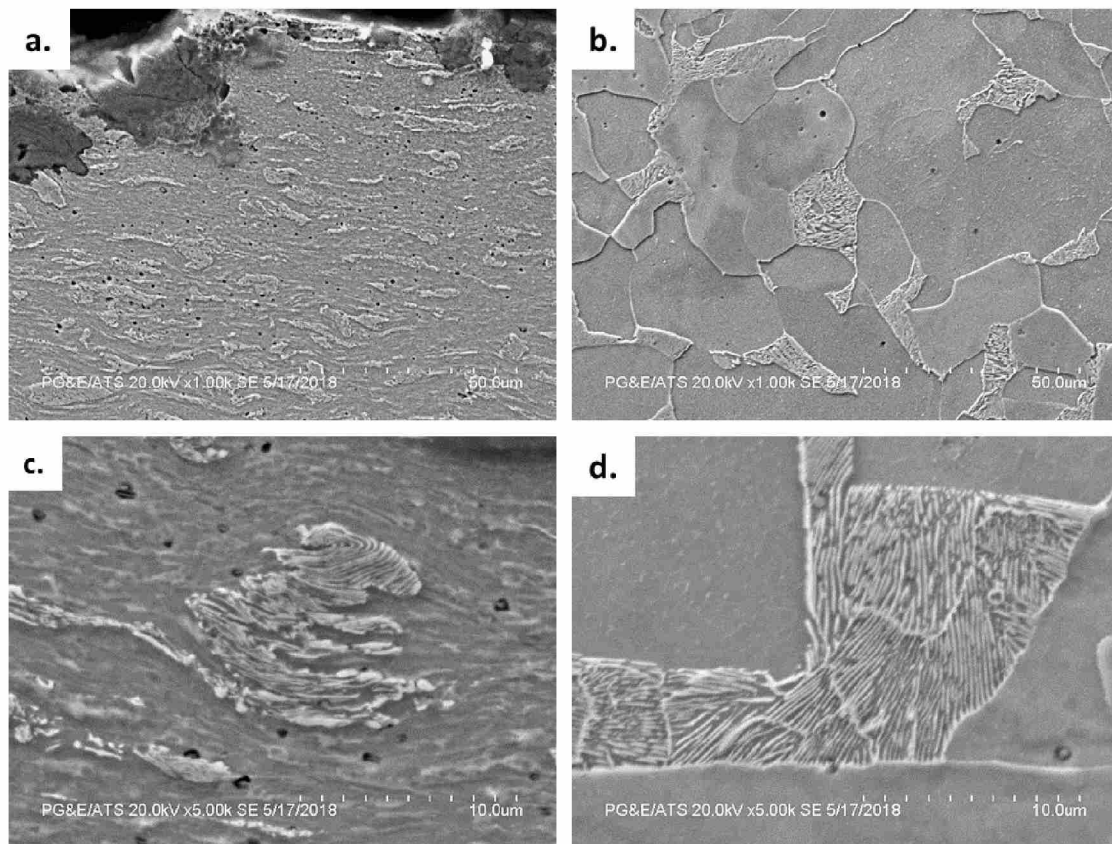
Figure 13: Scanning electron micrographs from the etched cross-section perpendicular to the wear surface of Plate 2. (a, c) From near the surface at 1,000x and 500x, and (b, d) from the bulk microstructure at 1,000x and 5,000x. Images a) and c) show severe breakup of the pearlite regions. Images b) and d) show large, intact pearlite colonies.

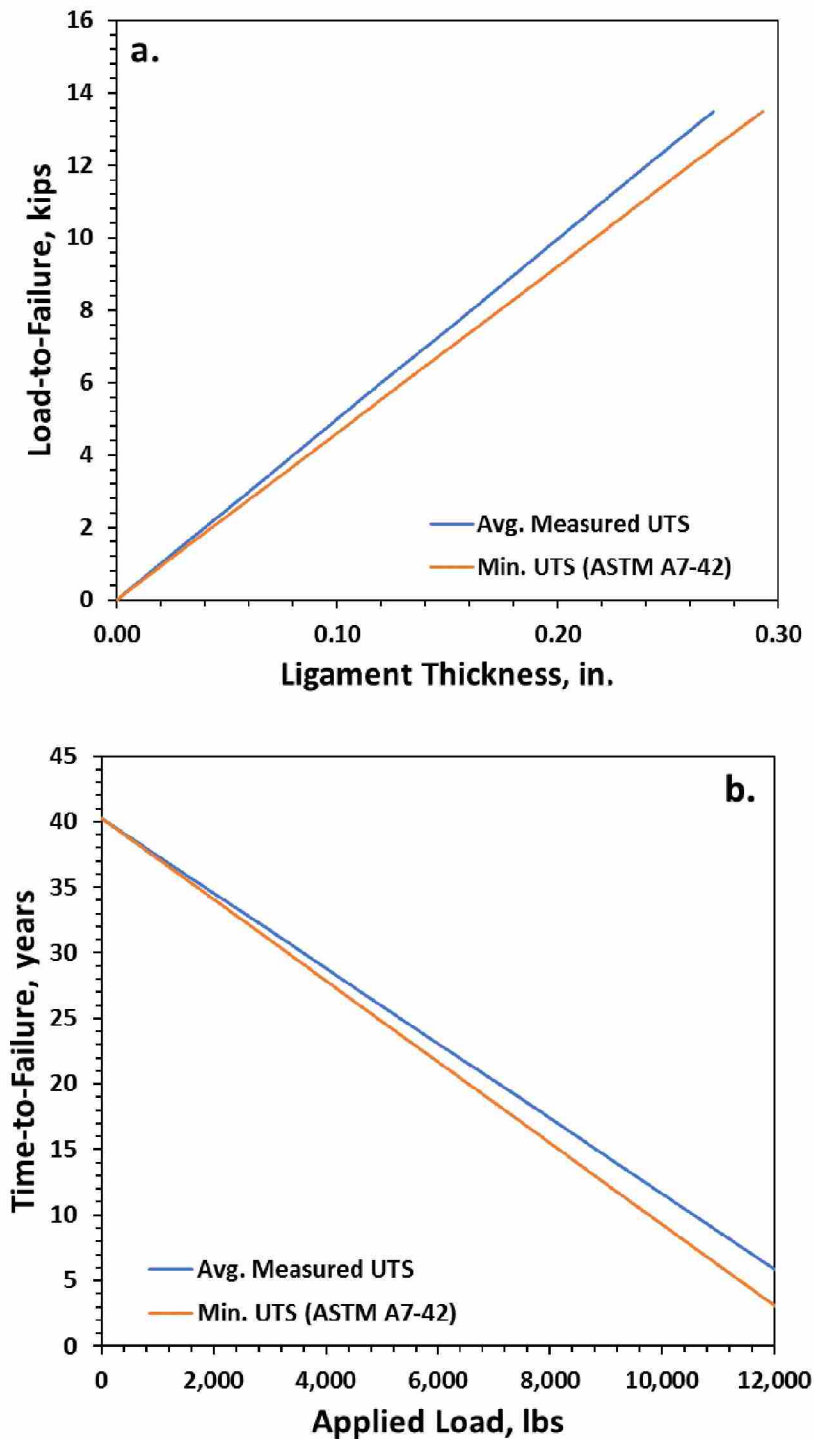
Figure 14: Results of mechanical calculations showing a) load-to-failure versus ligament thickness, and b) time-to-failure versus applied load. Both calculations assume shear tear-out and estimate shear rupture strength to be 60% of UTS. Time-to-failure assumes the wear rate to be 0.007"/year starting from the minimum observed ligament thickness (0.282").
